U S NAVY RESPONSE TO SOUTH CAROLINA DEPARTMENT OF HEALTH AND  
ENVIRONMENTAL CONTROL COMMENTS RCRA FACILITY INVESTIGATION ADDENDUM  
AND CORRECTIVE MEASURES STUDY WORK PLAN AREA OF CONCERN 596 (AOC 596)  
ZONE E CNC CHARLESTON SC  
3/13/2003  
CH2M HILL

AOC 596 Zone E  
RFE Report Addendum + CWB Workplan

**Re:** CH2M-Jones' Responses to Comments by SCDHEC regarding the *RFI Report Addendum and CMS Work Plan, AOC 596, Zone E, Revision 0*

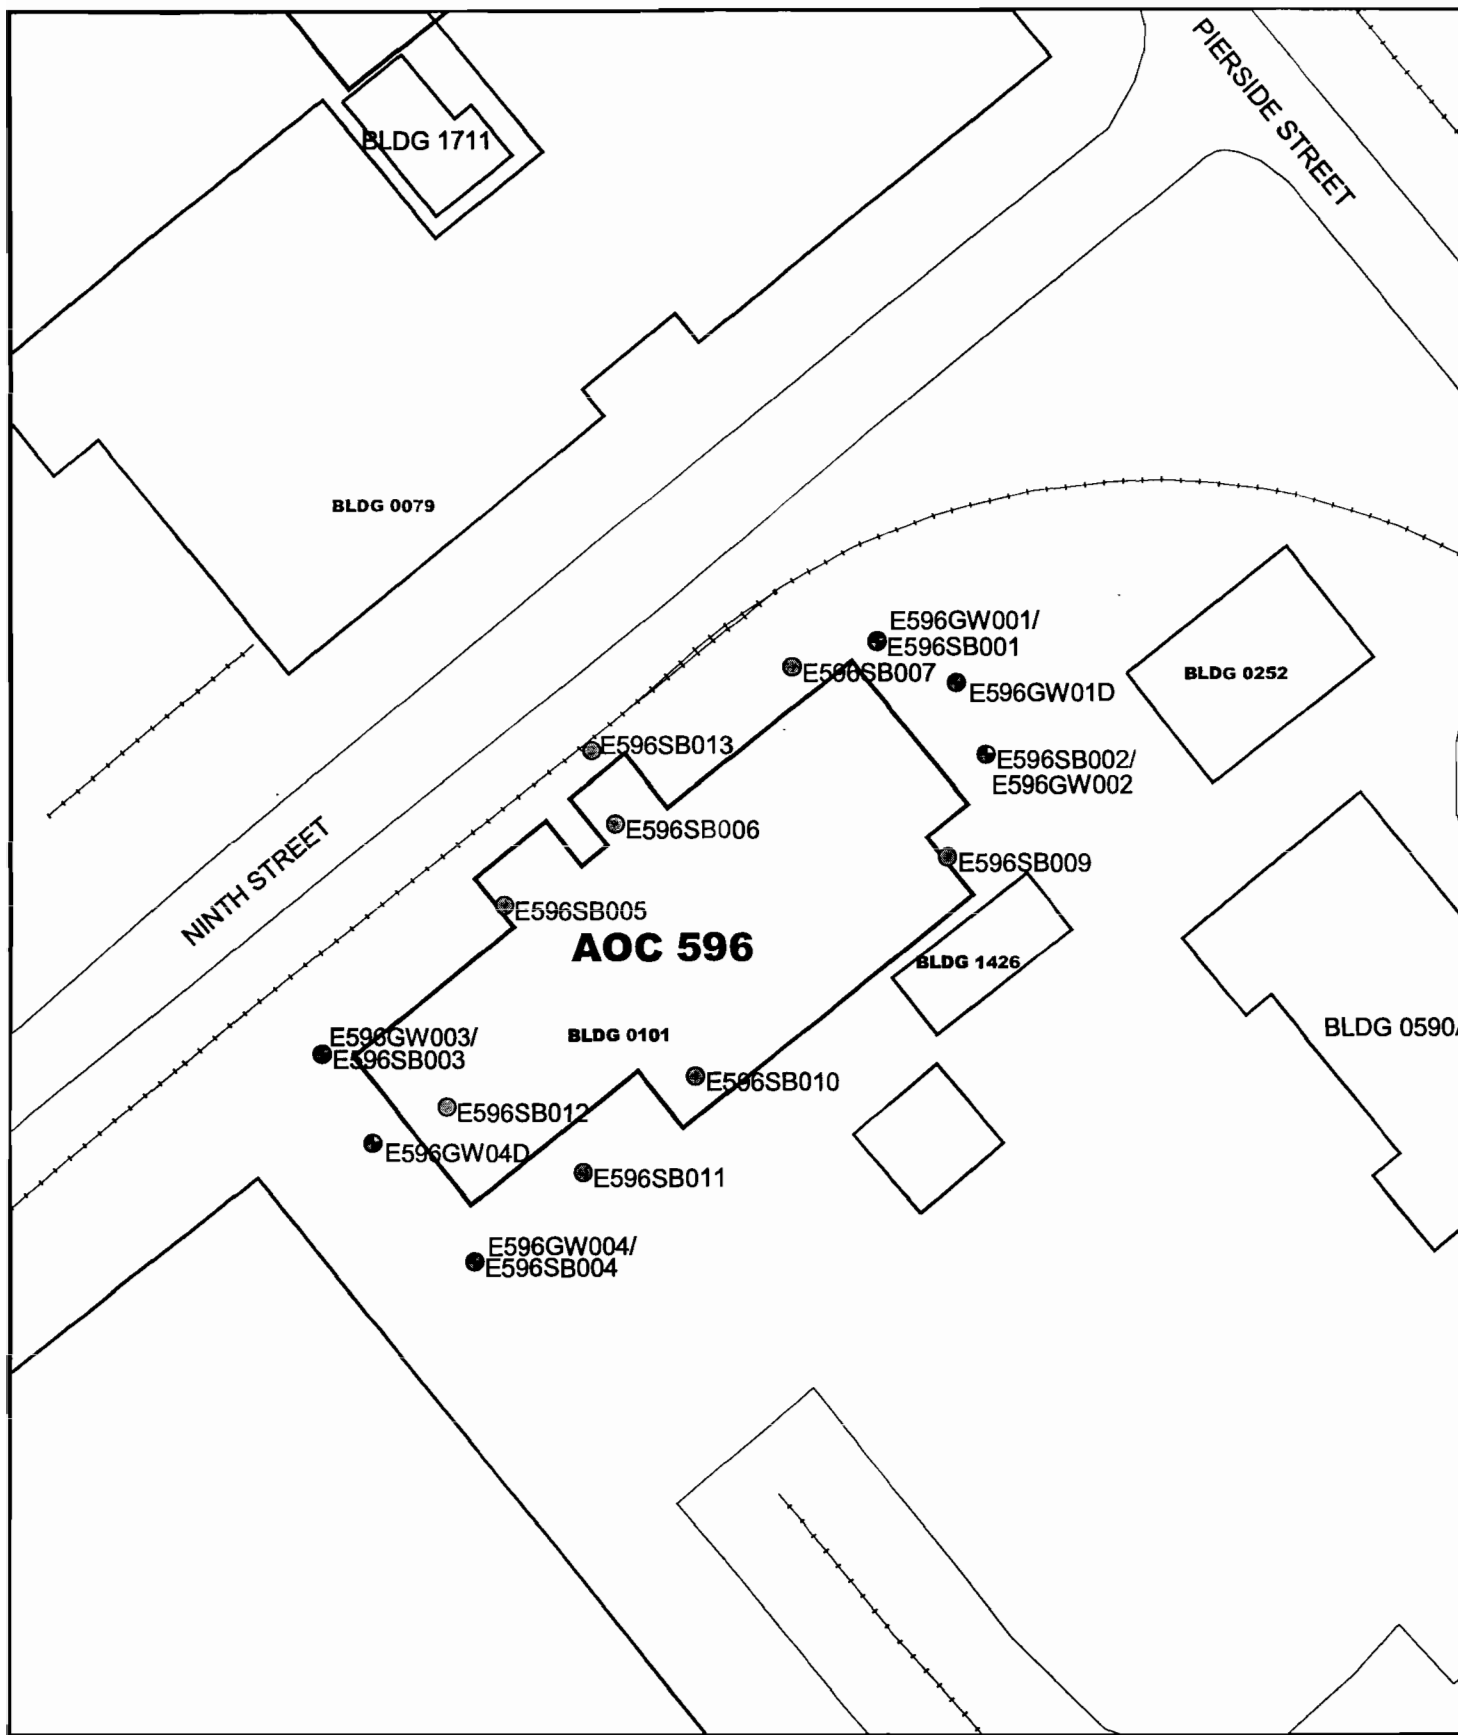
**Figure 2-1**  
RFI Sampling Locations  
AOC 596, Zone E  
Charleston Naval Complex

1. Figure 2-1 does not indicate the soil sampling location of:
  - a. E596SB005
  - b. E596SB008

*The Zone E RFI Report, Revision 0 (EnSafe, 1997) indicates in Section 10.45.1 that the soil boring at E569SB008 could not be advanced due to the thickness of the cement floor being greater than 3 feet. Therefore, no sample was taken at E596SB008. Figure 2-1 inadvertently omitted the location of E596SB005. A copy of the revised Figure 2-1 is attached and will be included in the Revision 1 of the RFI Report Addendum/CMS Work Plan (RFIRA/CMSWP).*

*Boring E596SB006 is already "bracketed" by borings E596SB005, E596SB007, and E596SB013 (see attached Figure 2-1). None of these three soil borings had BEQs greater than the sitewide reference concentration.*
